**GR-326:  
STRENGTHENING  
THE WEAKEST LINK  
IN MODERN DAY  
ULTRAFAST OPTICAL  
NETWORKS**

Revision 2

# GR-326: STRENGTHENING THE WEAKEST LINK IN MODERN DAY ULTRAFAST OPTICAL NETWORKS

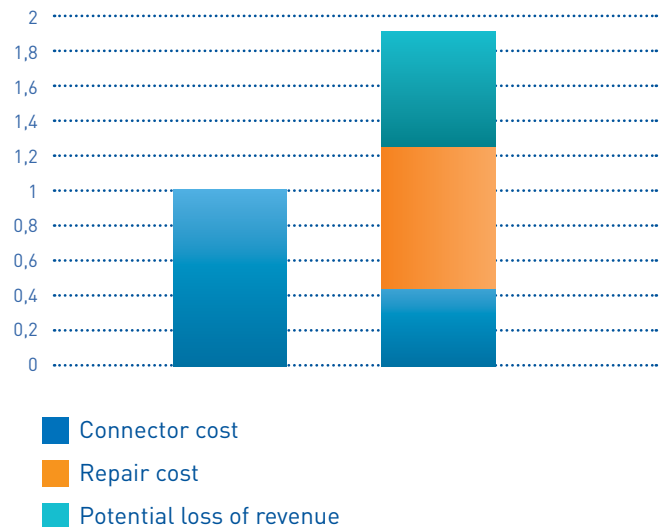
Figure 4

### Total Cost of Ownership Comparison between GR-326CORE vs non-GR-326CORE Connectors

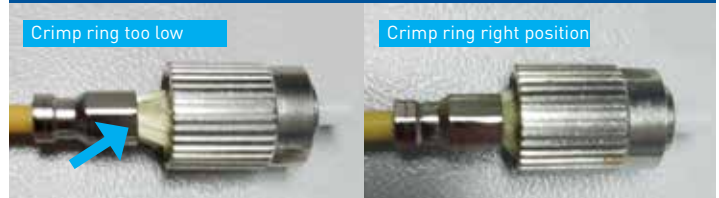
**Figure 8:** Improper crimp ring placement during crimping

Due to improper crimp ring placement during crimping, the upper most FC connector in Figure 8 exhibited cable retention pull force well below the requirements specified GR-326. More seriously shown in Figure 9A & 9B, where there is a gap between the ferrule and the flange during the termination process. If the gap is too big, that place becomes an air pocket which will, during expansion at higher temperature, exert pressure on the fiber thus causing the fiber to break (Figure 9C). A sample of a good connector can be seen in Figure 9D.
